# Manhole Inspection Summary

Manhole # S09WW\_022MH

**Location** Address: **3302 LIBERTY HEIGHTS AVE**

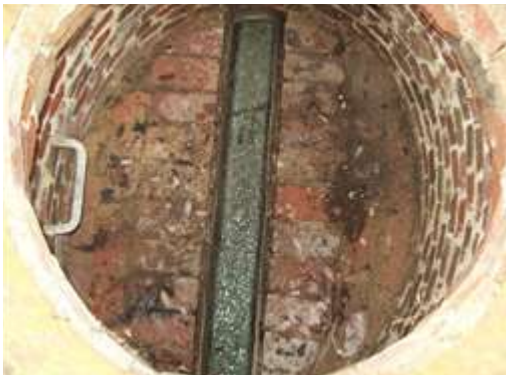
Defect 1

Condition: ☐ Sound ☐ Cracked ☐ Root Intrusion ☒ **Loose Brick** ☐ Deteriorated

Loose bricks of barrel

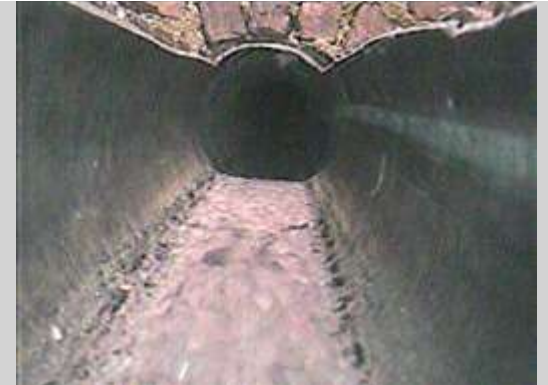
12 O'Clock Outflow

8 in. Circular Gravity Sewer  
Pipe Out @ 12 O'Clock

Pipe Height: (in.) Direct  
Pipe Material: **Unknown** ☐ Pipe Lined  
Invert Depth: **5.10** (ft.) Flow Characteristics: **Fast**  
Deposits: ☒ None ☐ Mud ☐ Sludge ☐ Debris ☐ Grease  
Silt Depth: (in.) Deposits Extent:  
Infiltration: **None** Pipe Seal Cond: **Sound**

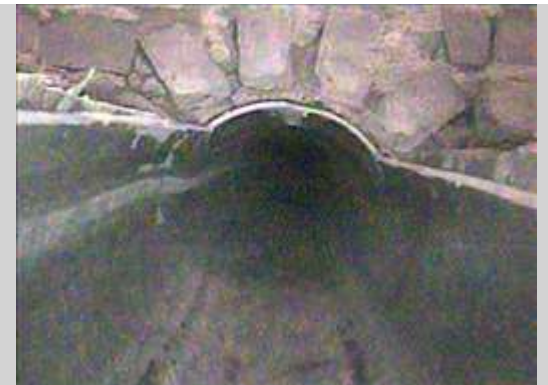
6 O'Clock Inflow

8 in. Circular Gravity Sewer  
Pipe In @ 6 O'Clock

Pipe Height: (in.) Direct  
Pipe Material: **Unknown** ☐ Pipe Lined  
Invert Depth: **5.04** (ft.) Flow Characteristics: **Fast**  
Deposits: ☒ None ☐ Mud ☐ Sludge ☐ Debris ☐ Grease  
Silt Depth: (in.) Deposits Extent:  
Infiltration: **None** Pipe Seal Cond: **Sound**
